LOW CARBON LIVING
CRC

Project RP1020

Field Performance of Geopolymer Concrete
Structures

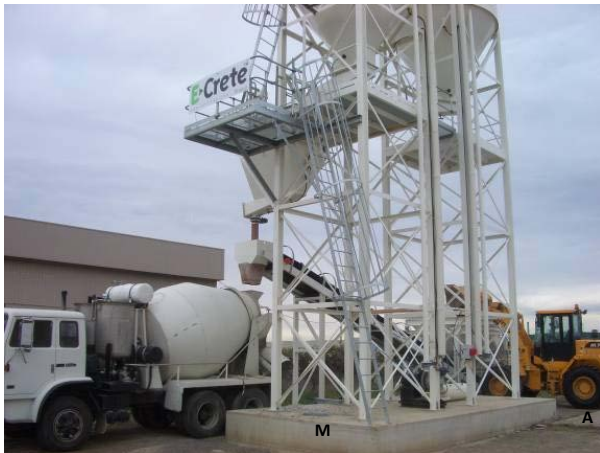
Figure 1. Main slab (M) and apron slab (A) at Campbellfield Site, VIC (source: www.zeobond.com).

Field testing of Geopolymer concrete was performed on two slabs at Campbellfield, Victoria. The site is 18 km north of the Melbourne CBD and the AS 3600 exposure classification is B1. The slabs were constructed by Zeobond in 2007. The main slab originally supported a batching plant and was built using concrete based on a 75% fly ash 25% slag blend activated with sodium hydroxide, potassium hydroxide and sodium silicate (Type 1 GPC). Adjacent to the main slab was an apron slab constructed with sodium hydroxide activated 70% fly ash 30% slag concrete (Type 2 GPC). Figure 1 shows the original slabs.

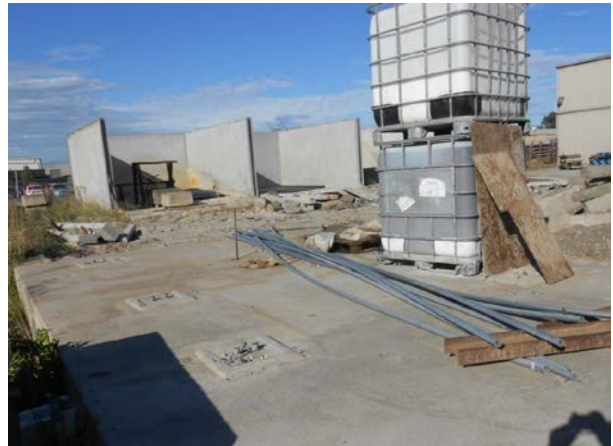
Figure 2. Main slab at Campbellfield site, VIC in March 2015.

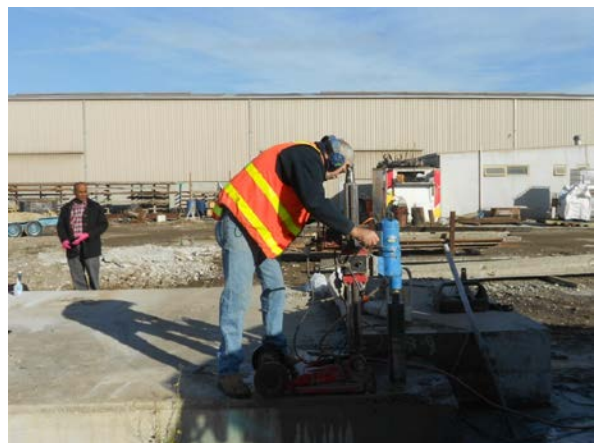
Figure 3. Extraction of cores from main slab at Campbellfield site, VIC in April 2015.

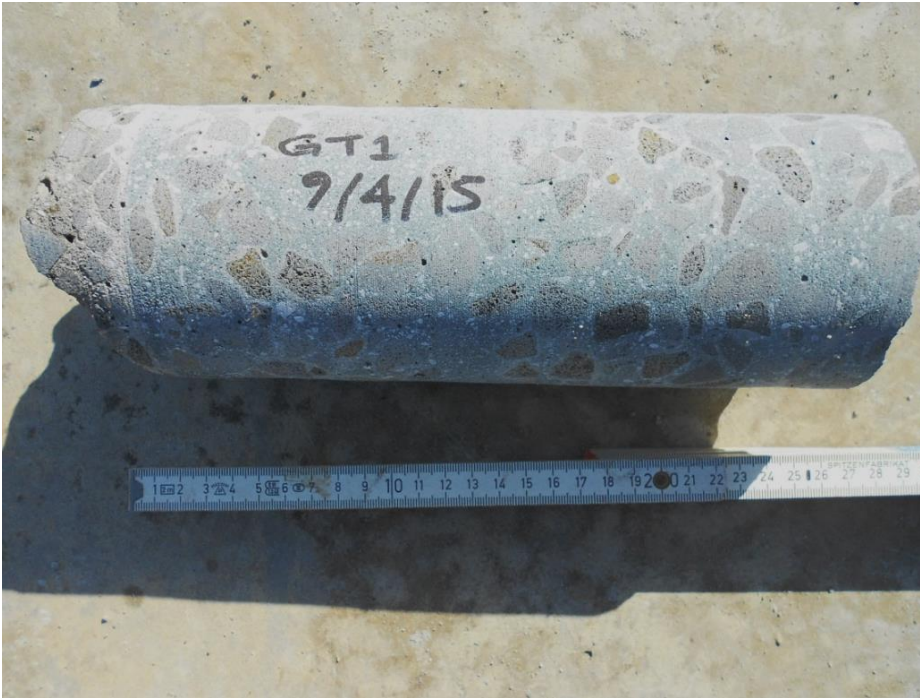
Figure 4. Typical core sample from main slab at Campbellfield site, VIC in April 2015.

Figure 3 shows the coring in progress and Figure 4 is a typical core sample.

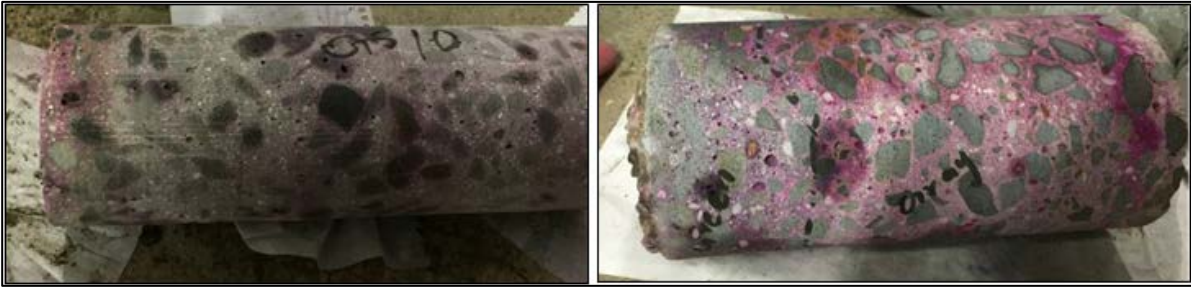
Figure 6. No clear carbonation front by phenolphthalein indicator for Type 1 and Type 2 specimens

Furthermore, phenolphthalein indicator did not always provide a clear carbonation front and in some cases it shows a light pink colour after the application of the phenolphthalein solution (Figure 6), this was also reported by other researchers [8-10]. In alkali activated slag concrete, phenolphthalein provided clear identification of carbonation front due to the formation of calcium carbonate product from the carbonation of $\text{Ca}(\text{OH})_2$ and C-S-H gels. However, in fly ash based Geopolymer concrete, formation of Na_2CO_3 do not provide the clear carbonation front with phenolphthalein indicator [8]. In this study, a fly ash and slag combination was used to make the Geopolymer binder. Therefore, the formation of both types of carbonation products (fly ash and slag reaction products) could be the reason for the clear carbonation front obtained in some cases and no visible carbonation front in others.

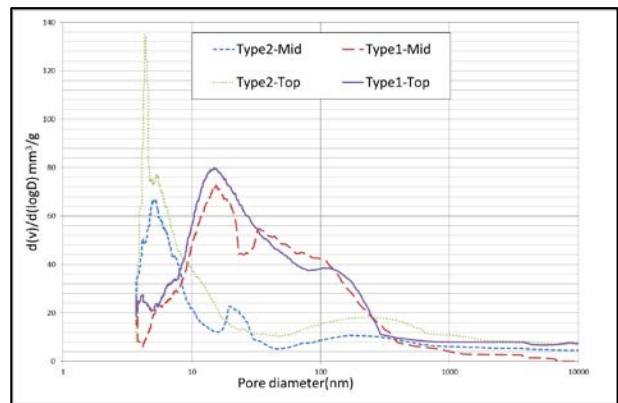
However, the Type 1 GPC still shows noticeable amount of pores with the diameter between 50 nm to 150 nm (Figure 12), which are harmful pores. Therefore, it can be concluded that the Type 1 GPC contain high amount of harmful pores which can promotes the penetration of CO_2 . This was also confirmed with the carbonation test results, where the penetration of CO_2 was high in Type 1 Geopolymer concrete surface in ambient environment.

Figure 12. Differential pore size distribution obtained for both types of Geopolymer concrete.

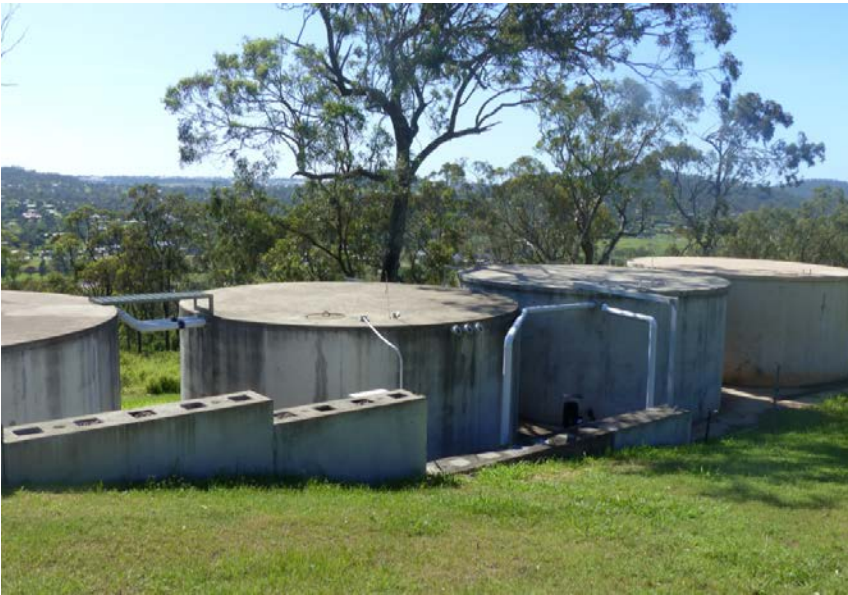
Geopolymer and OPC concrete water tanks located at Toowoomba site, Queensland were investigated in December 2015, as shown in Figure 13. The water tanks experienced cracks that extended to the outer surface of the concrete tank. In both cases, the cracks were partially healed. Figure 14 shows the surface crack in one Geopolymer concrete water tank.

Figure 13. Geopolymer and OPC concrete water tanks at Toowoomba site, QLD, in December 2015.

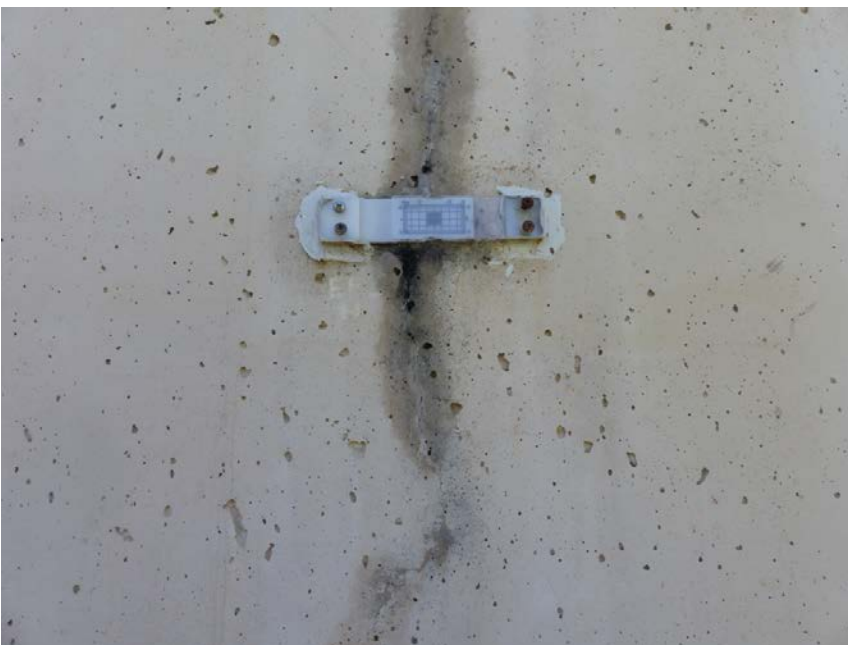
Figure 14. Surface crack of Geopolymer concrete water tank at Toowoomba site, QLD, in December 2015.

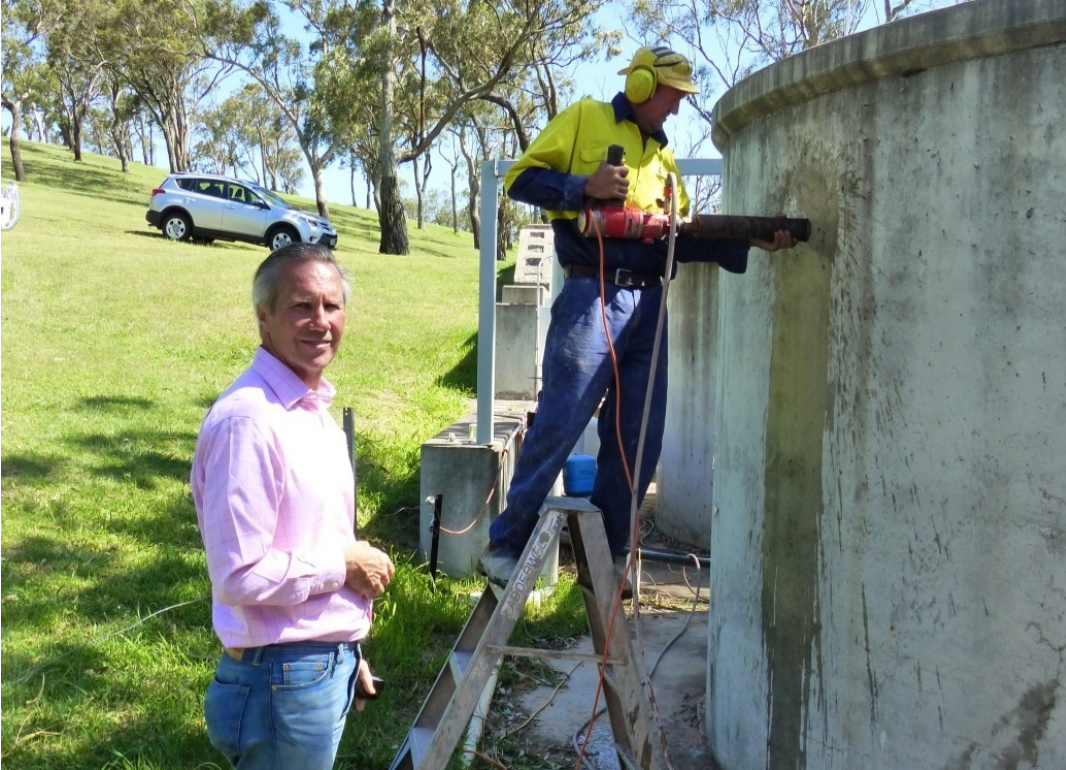
tank: one specimen along the crack and another one having where no cracking was evident. Figure 15 illustrates coring of the Geopolymer concrete water tank in progress. The core samples for Geopolymer (EFC) and OPC concrete are given in Figures 16 and 17, respectively.

Figure 15. Coring of OPC concrete water tank at Toowoomba site, QLD, in December 2015.

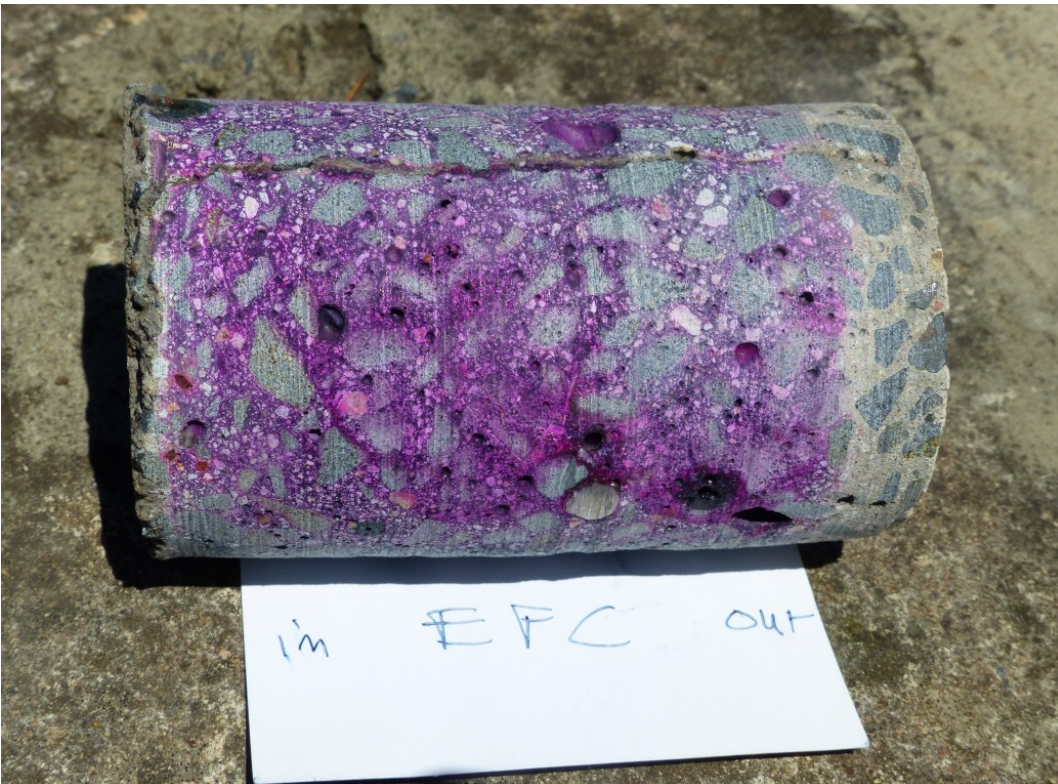
Figure 16. Geopolymer concrete core taken from water tanks at Toowoomba Site, QLD, in December 2015.

Figure 16 and Figure 17 show the core specimens after spraying of phenolphthalein indicator. It can be seen that

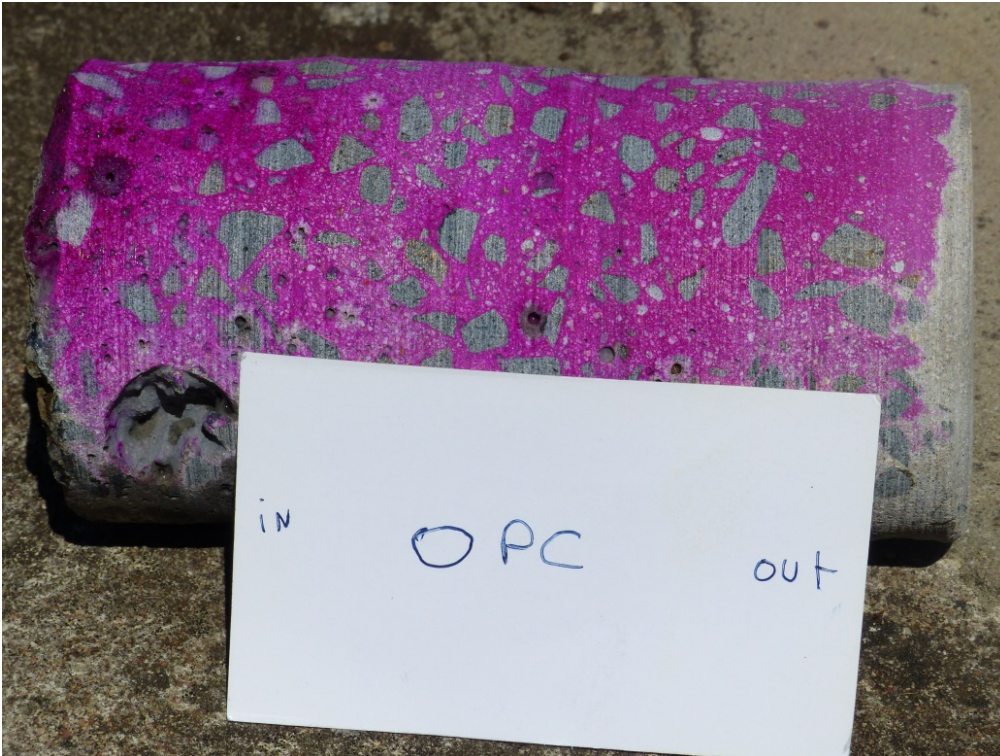
Figure 17. OPC Concrete core from water tanks at Toowoomba site, QLD, in December 2015.

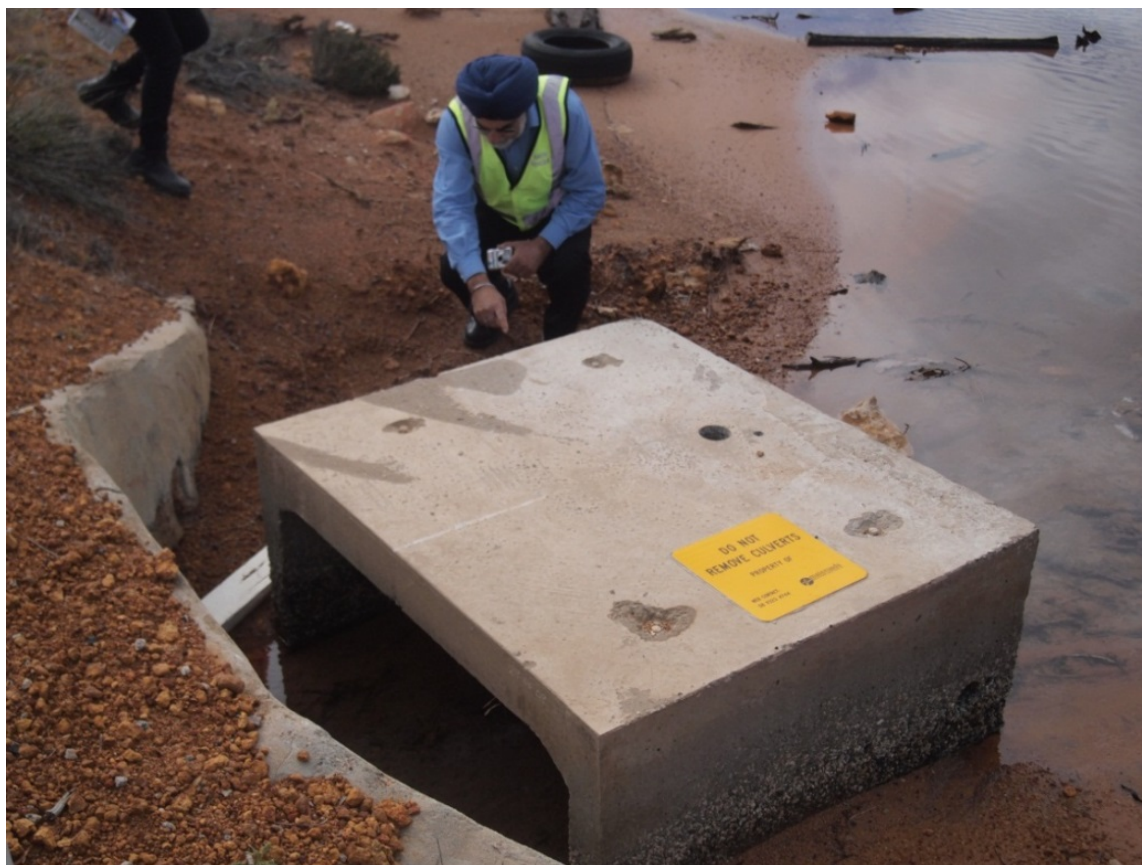
Figure 21. Geopolymer concrete culvert at Lake King site, WA, in October 2015.

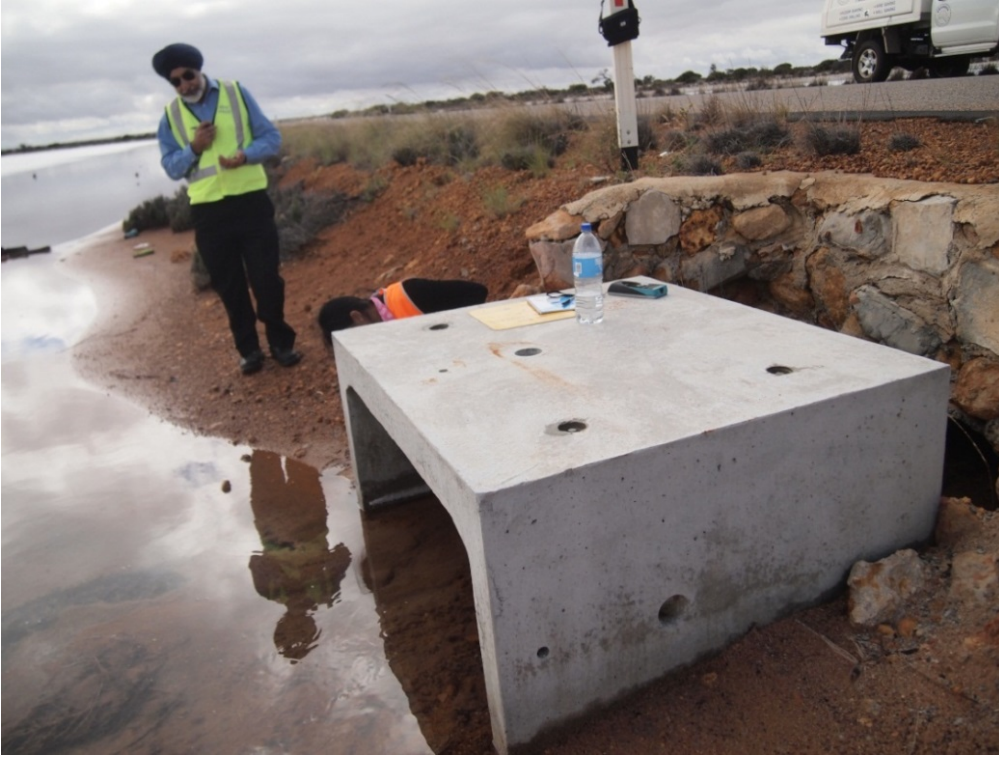
Figure 22. OPC concrete culvert at Lake King site, WA, in October 2015.

Figures 21 and 22 show, respectively, the Geopolymer and the OPC concrete culverts.

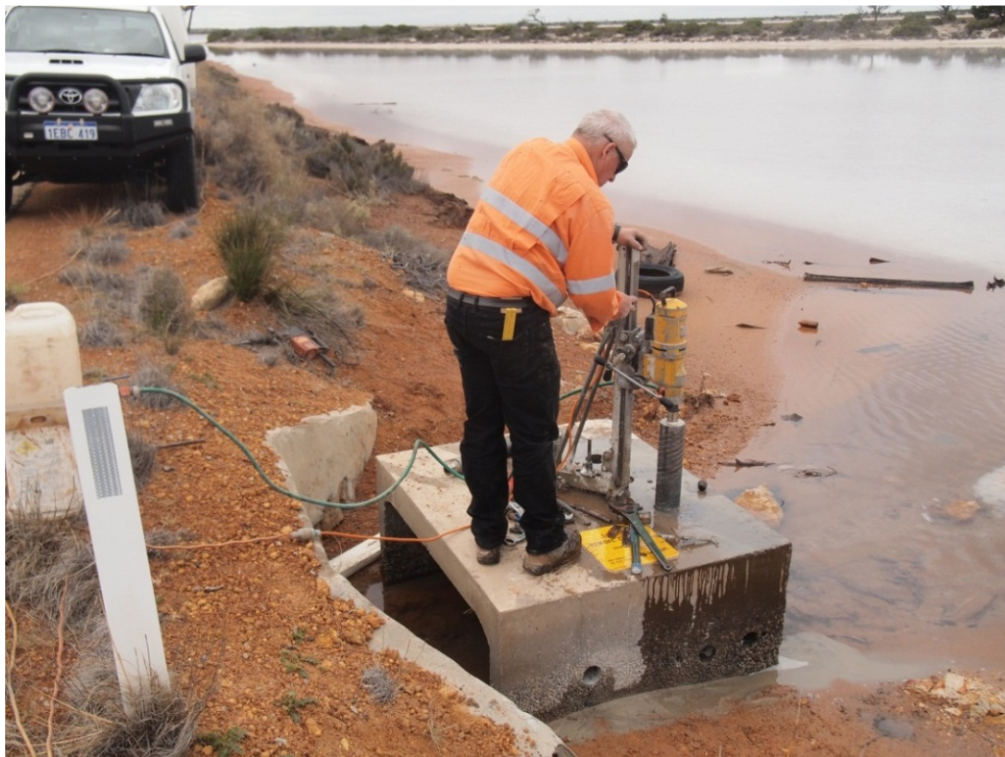
Figure 23. Coring of Geopolymer concrete culvert at Lake King site, WA, in October 2015.

Figure 23 illustrates coring of the Geopolymer concrete culvert in progress and Figure 24 shows a typical core sample.

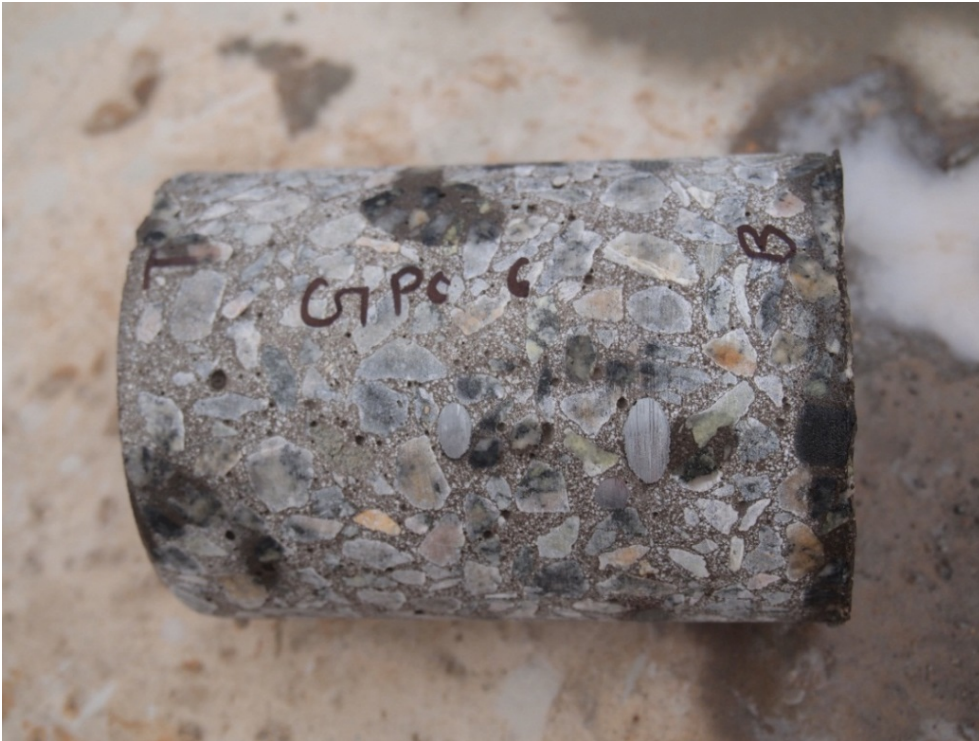
Figure 24. Typical Geopolymer concrete core sample from Lake King site, WA, in October 2015.

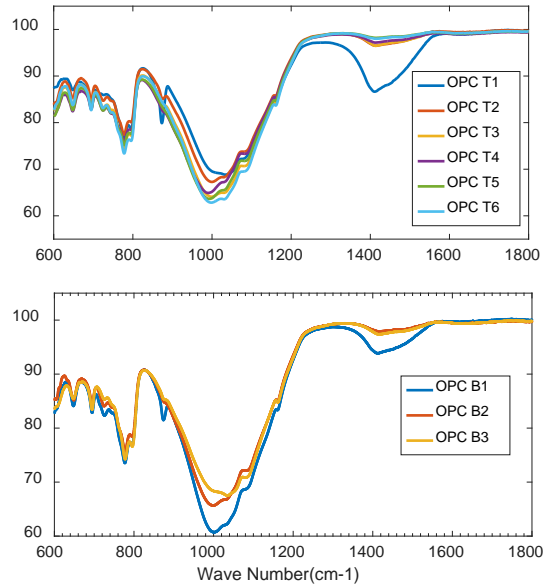
Figure 29. FTIR spectrum of OPC concrete samples with various depth intervals.

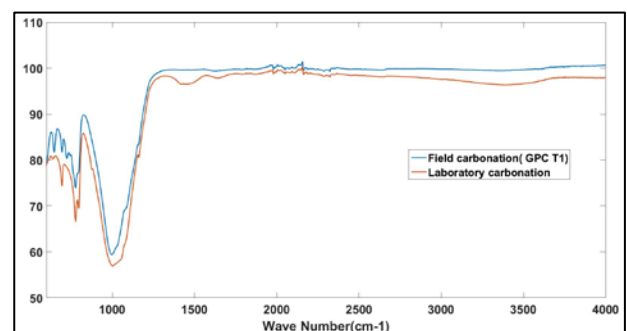
concrete [29], the concentration of CO_2 used in this experiment was 1% to produce the same type of products that would form under natural carbonation conditions. Figure 30 shows the FT-IR results for the sample collected from a specimen that was exposed to the carbonation chamber for 4 weeks and the powder sample extracted from the GPC culvert core specimens at a depth level of 0-5 mm. According to Figure 30, the C–O bond was recognized in laboratory prepared GPC samples at 1450 cm^{-1} . This suggests that carbonation components have been formed in the fly ash based Geopolymer concrete samples. Therefore, carbonation reaction products in the GPC culvert appear to have dissolved in water from rain and the lake under field exposure conditions. In contrast, a solid dense layer of calcite (CaCO_3) is formed as a result of carbonation in OPC concrete by the dissolution of CO_2 in the concrete pore fluid and this reacts with calcium from calcium hydroxide ($\text{Ca}(\text{OH})_2$) and calcium silicate hydrate. The formation of this water insoluble densified layer on concrete surface further reduces the carbonation rate.

Figure 30. FTIR spectrum of GPC concrete samples (field and laboratory)

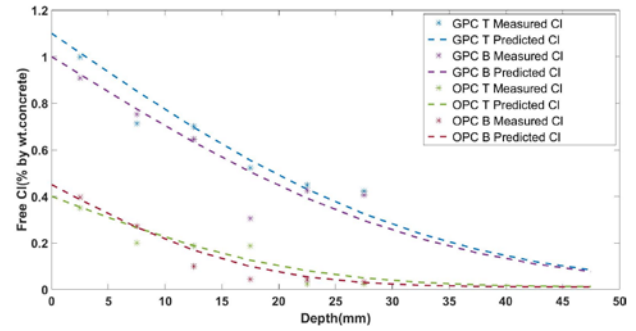
The test results of the free chloride measurements of core specimens extracted from the leg parts of the box culvert are shown in Figure 31. Free chloride profiles are plotted with the Fick's second law mathematical equation. According to Figure 31, the series indicated as 'GPC T' and 'GPC B' are associated with the free chloride profile of GPC concrete samples, collected from outer and inner exposed surfaces, respectively. Similarly, 'OPC T' and 'OPC B' were assessed with the powder samples collected from outer and inner surface of the OPC concrete culvert. As shown in Figure 31, chloride penetration in GPC specimens was found to be greater than in OPC concrete. The free chloride contents at 30 mm depth from the outer surface and inner surface of GPC concrete exceeded or were close to the value of 0.4% free chlorides by weight of concrete. This indicates that the chloride content of GPC is sufficient to initiate corrosion activity in the reinforcement due to a rupture of the passive layer. On the other hand, the amount of free chloride in the OPC concrete was low compared to GPC concrete. Inspection of the steel bars in the GPC concrete also confirmed the presence of corrosion whereas bars in the OPC concrete were not corroded.

Figure 31. Free chloride variation with depth values.

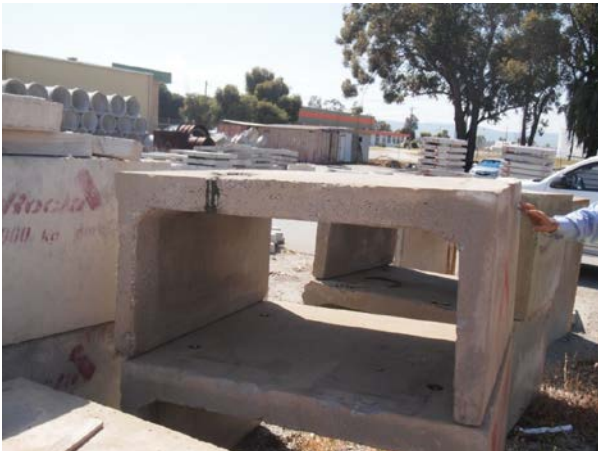
Figure 42. Geopolymer concrete culvert at casting yard in Perth, WA, in October 2015.

The culverts are shown in Figures 42 to 44. In-situ testing of the culverts included resistivity measurements. Core samples were extracted and subjected to the following tests:

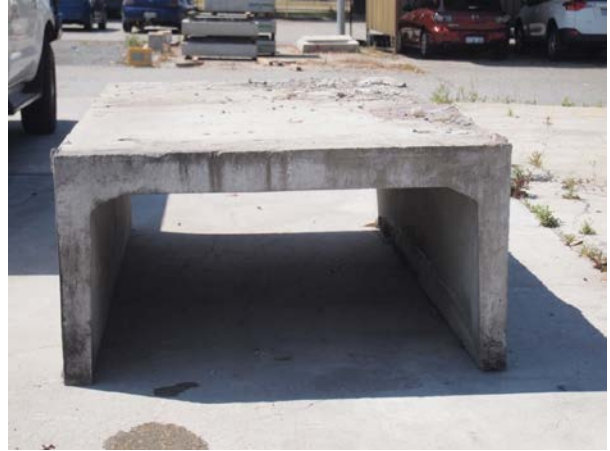
Figure 43. OPC concrete culvert at casting yard in Perth, WA, in October 2015.

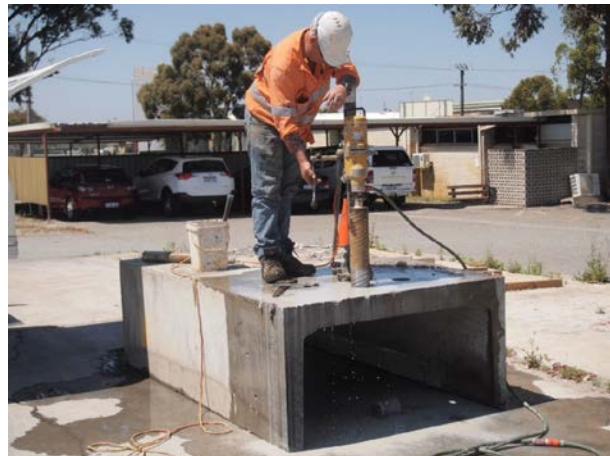
Figure 44. Coring of OPC concrete culvert at casting yard in Perth, WA, in October 2015.

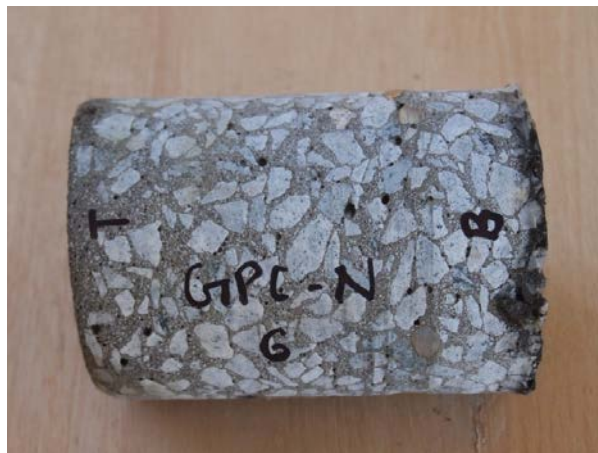
Figure 45. Typical Geopolymer concrete core from culvert at casting yard in Perth, WA, in October 2015.

Figure 45 shows a typical GPC core.

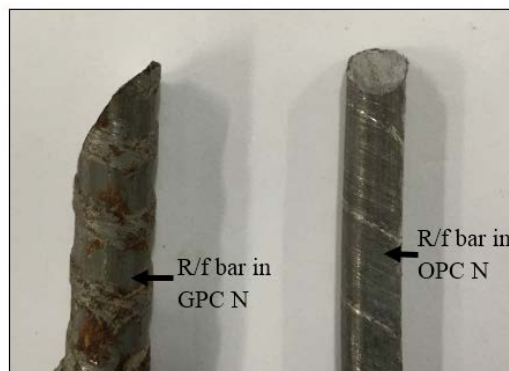
around the reinforcement. This passivation layer will be de-passivated with carbonation process due to alkalinity deduction (pH deduction to less than 9.0) in the concrete. Photos of embedded reinforcement bars which were located in the leg parts of the GPC and OPC concrete culverts with 45 mm cover are provided in Figure 50. The reinforcement bar in GPC displays some superficial corrosion. As no corrosion measurements were taken, and storage was not in a controlled environment, no conclusions are drawn on this observation.

Figure 50. Visual observation of embedded steel bars extracted from GPC and OPC concrete at 8 years exposure (45 mm cover).

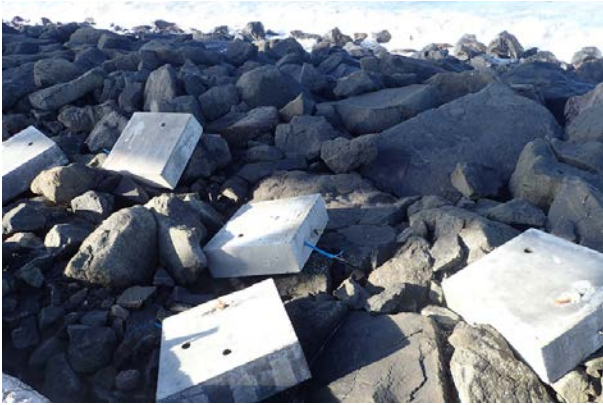
Figure 54. GPC and OPC concrete blocks in Portland, Victoria, in June 2016.

Cores were sampled from concrete blocks (Figures 54 to 56) exposed to marine environment. Analysis carried out aimed to compare the performance against chloride penetration of GPC to that of OPC reference concrete.

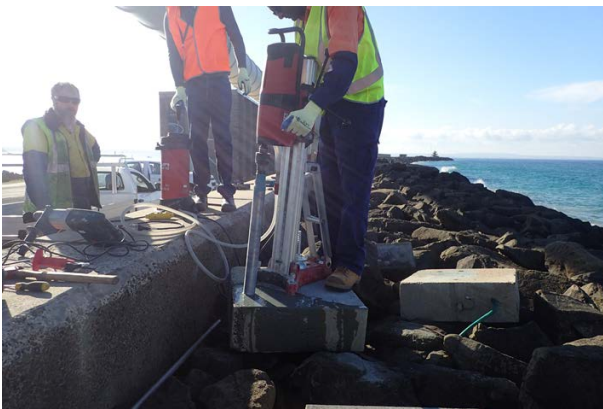
Figure 55. Coring of GPC block at Portland, Victoria, in June 2016.

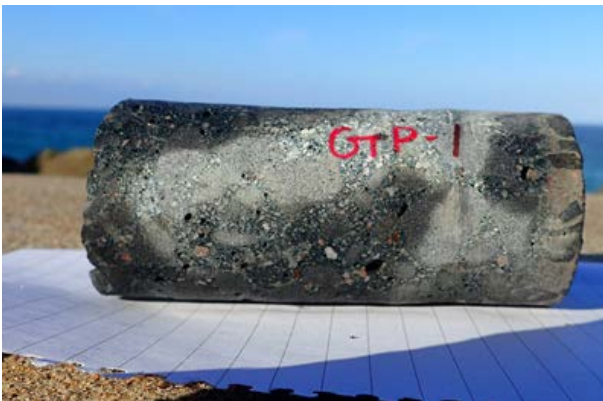
Figure 56. Typical Geopolymer concrete core from block at Portland, Victoria, in June 2016.

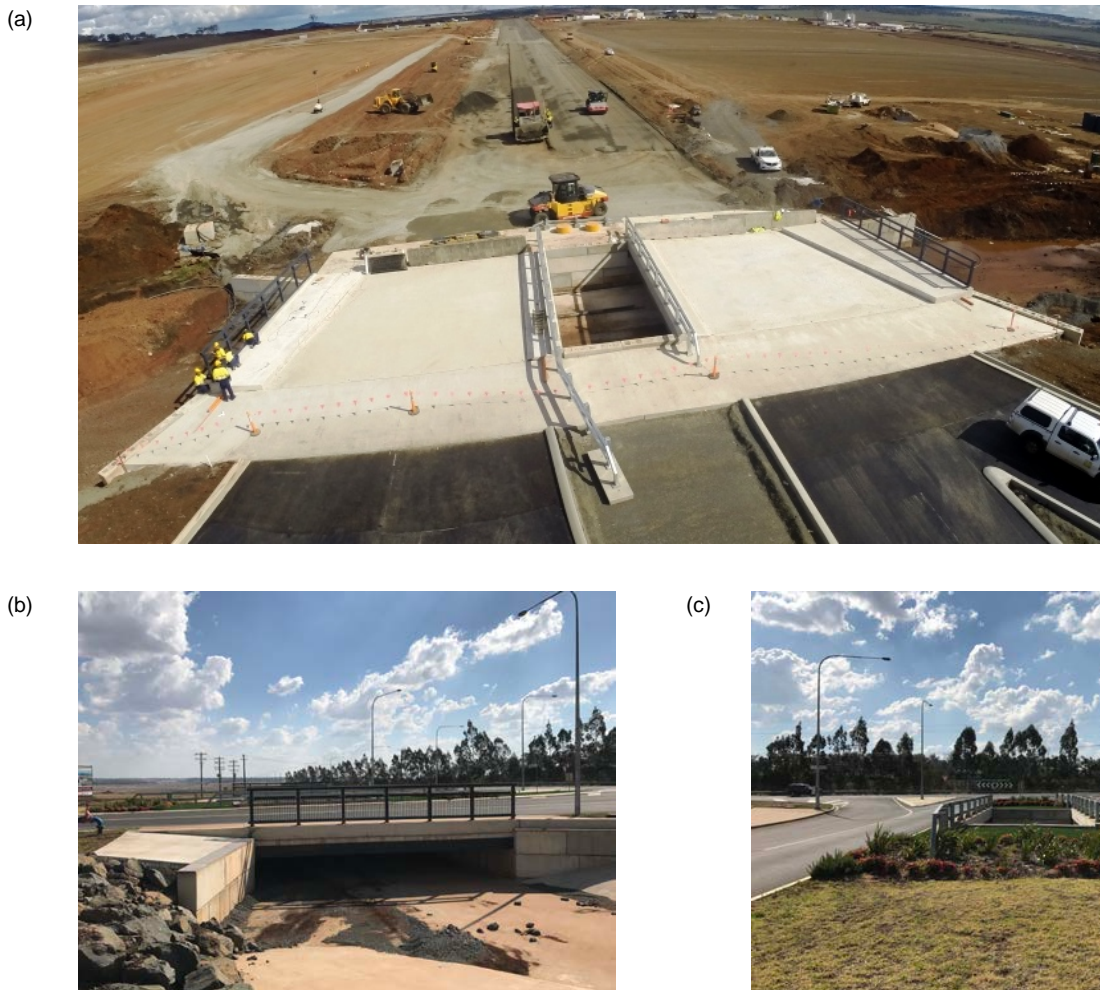
Figure 64. (a) Geopolymer concrete bridge at Wellcamp airport business park precinct, Toowoomba Queensland: (a) nearing completion at in in September 2014 (photo courtesy of Wagners); (b)-(c) completed bridge and road development (photo taken August 2017).

The performance of a Geopolymer concrete bridge in Queensland has been monitored since September 2014. The two-way bridge, located on International Drive near the junction of Cecil Plains Road, and about 140 km from the coast, was constructed by Wagners in 2014 as the entry to the Wellcamp Business Park in Toowoomba, Queensland. The structure comprises of two bridges, each acting as a one-way passageway. Figure 64a shows the bridge near completion at September 2014 and Figure 64b as it is in August 2017.

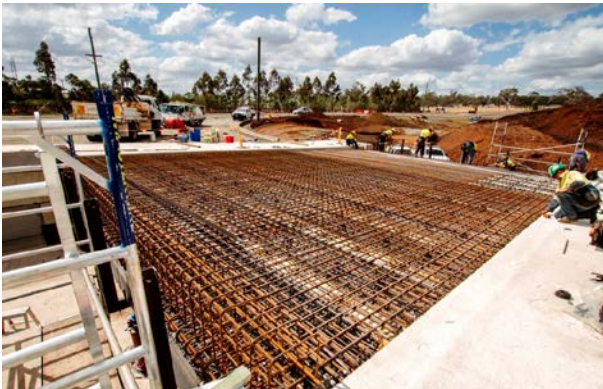
The deck and kerb were constructed from Wagner's Earth Friendly Concrete (EFC) which is a binding mixture of fly ash and blast furnace slag, where there was no inclusion of OPC. The 28-day compressive strength of the material is 40MPa with a corresponding tensile flexural tensile of 5.5 MPa and an elastic modulus of 28 GPa. The deck consists of N16 bars at 150 mm each way on the top, and N16 bars at 125 mm each way on the bottom. The footpaths on both bridges have N12 bars at 150mm each way on the top only. The reinforcement installation in the East Bridge is shown in Figure 66.

Figure 66. Reinforcement Installation at Toowoomba Bridge Site, QLD in September 2014 (Wagners).

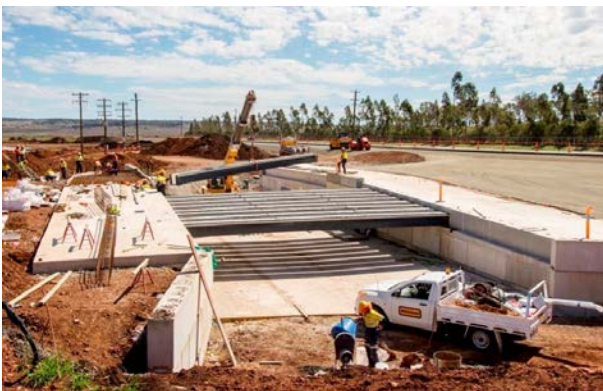
Figure 67. Installation of FRP Girders at Toowoomba, QLD, in September 2014 (Wagners).

Fibre Reinforced Plastic (FRP) composite elements form the girders of the bridge structure that support the 200 mm road deck. FRP is a promising, and relatively new, material that is substantially lighter than steel of concrete while also being easier to install. Since these girders were not constructed from Geopolymer concrete, the strain and temperature data obtained from the applied sensors were not analysed within this project. Figure 67 shows the installation of FRP girders in the East Bridge in September 2014.

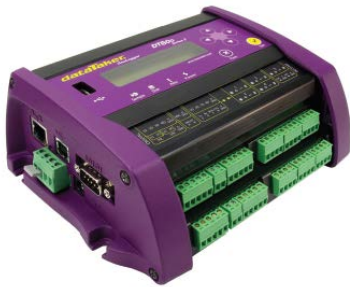
A DT80 Series 2 data logger were utilised in the project to collect and store the sensing data from the VWSG and RFSG devices, as shown in Figure 72. The frequency for data collection was programmed at once per 30 minutes. The monitoring data stored locally can be retrieved by USB input, FTP, cell phone, Ethernet or

Web. This is achieved by converting the incoming analogue signal generated by the sensing devices into a digital signal, allowing for it to be stored for long periods of time or transmitted back to the office. The DT80 had a range of 12 digital channels that allows the easy storage and transmittal of data while it also is capable of processing up to 300 analogue inputs when connected to a CEM20 channel expansion module. The average power consumption of the DT80 was 1.35W (12VDC and 112.5mA) with a peak power of 12W (12VDC and 112.5mA).

Figure 72. DT80 Series 2 data logger (dataTaker).

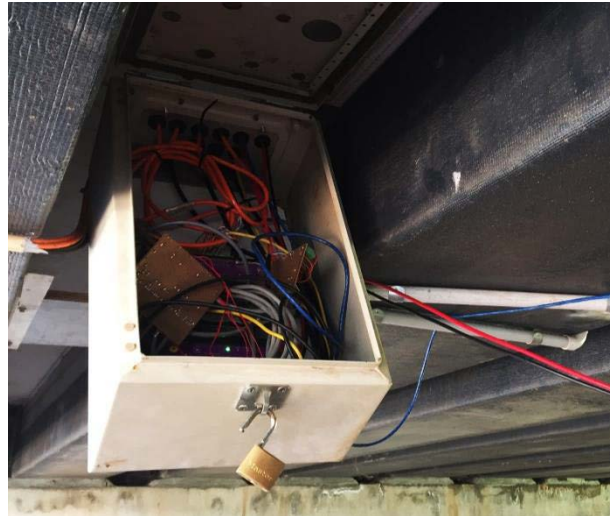
Once the monitoring system was installed, a water resistant enclosure was fabricated and mounted beneath the Geopolymer concrete slab to securely accommodate the DT80 data logger and the CEM20 channel expansion module, as shown in Figure 74.

Figure 74. Control box of the monitoring system at Toowoomba Bridge site, QLD.

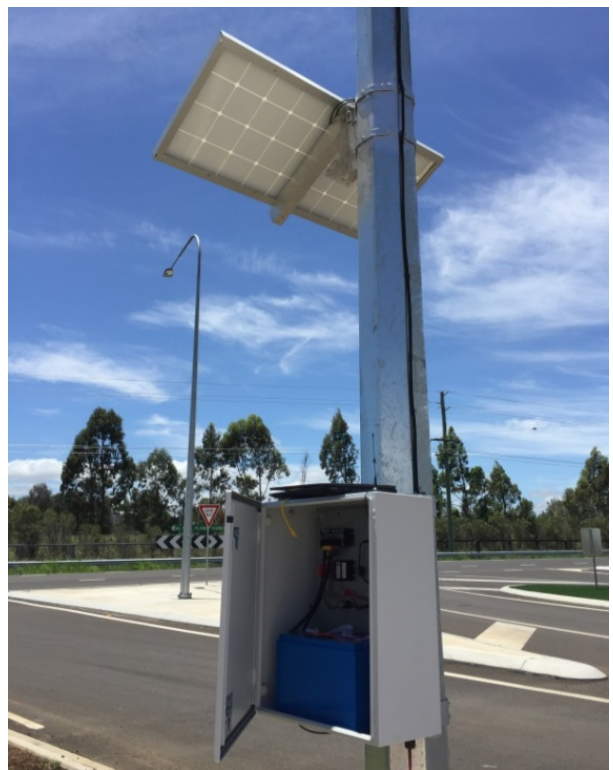
A solar power supply system was added to the bridge site in December 2015 to allow 24/7 continuously monitoring of the bridge, as shown in Figure 75. A Comset 4G industrial Modem was also installed for retrieving stored monitoring data remotely. Figure 76 shows the controller and battery of the solar power system, as well as the 4G modem.

Figure 75. Solar power supply system used at Toowoomba Bridge site, QLD.

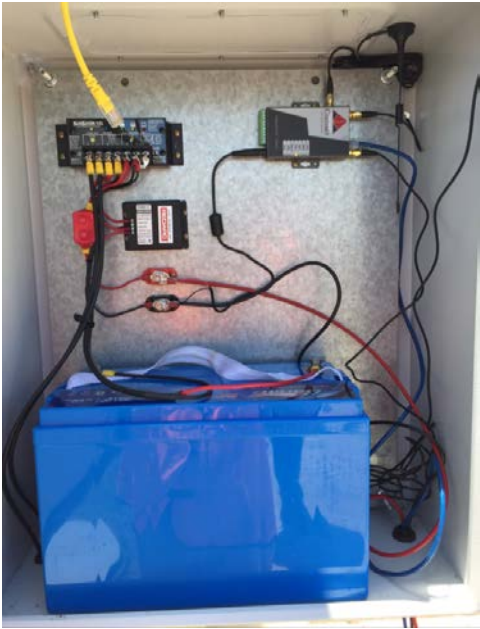
Figure 76. Interior view of the solar control box at Toowoomba Bridge site, QLD.

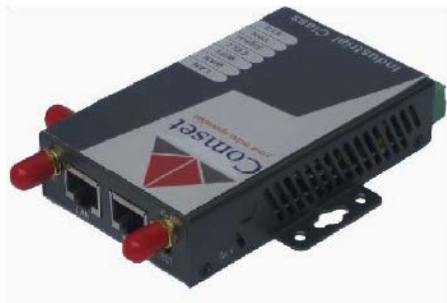
Wireless communication is also introduced into this monitoring system. A 4G Wi-Fi router (Figure 77) was selected from Comset Inc. (Model: CM685P-W). It possesses a fast internet connect with download speeds of up to 21 Mbps and is designed to comply with Australian telecommunication standards. It performs fast and reliable data communication for a broad range of Machine-to-Machine (M2M) applications.

Figure 77. CM685P-W 4G Wi-Fi router.

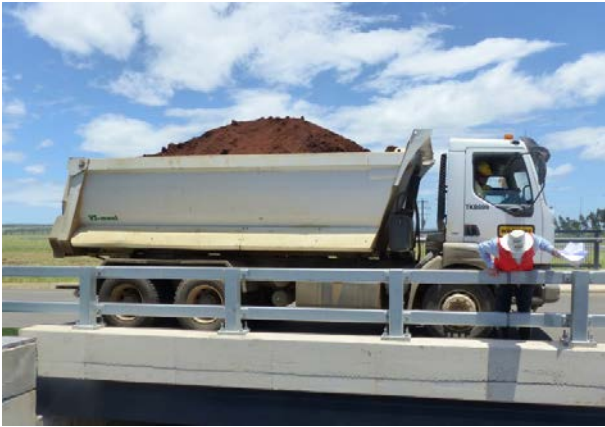
A load testing has been carried out on the bridge to assess the response to live loading. The test was divided into several scenarios using a known weight truck parking at different locations along the span. Three truck positions were selected with 5 mins parking time at each location which allows sensors to record the response of the bridge sufficiently. The truck started at the southern slab end and drove through the traveling lane. The distances from the rear axle to the southern edge of bridge entry were 1.01 m, 5.65 m and 10.35 m respectively of the three parking locations (Figures 78 to 80). Meanwhile, the measurement interval of the strain gauge was adjusted to 1 min providing five recordings at each location. The truck total weight is 38 tonnes with 13 tonnes self-weight and 25 tonnes fully loaded with clay. Each axle is estimated with an average load of 63.33 kN.

Figure 78. Live load testing: truck position 1.

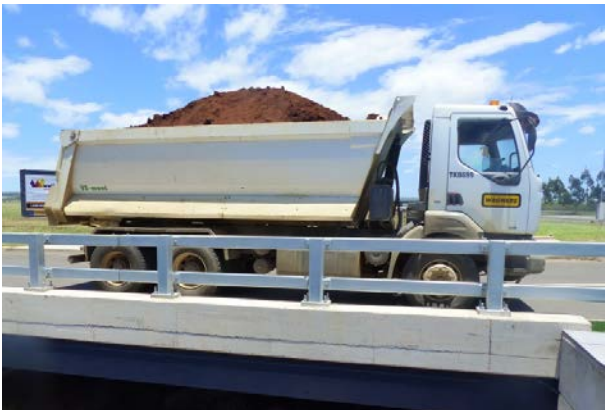
Figure 79. Live load testing: truck position 2.

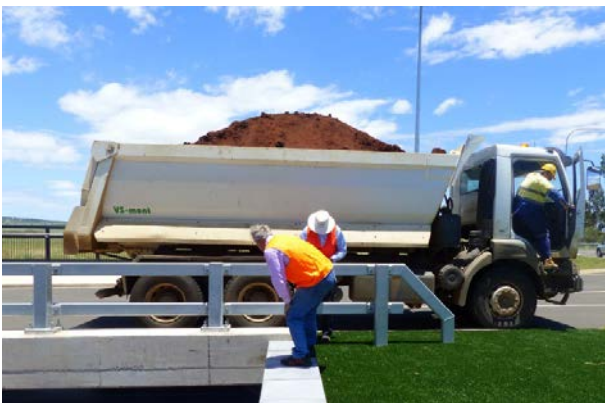
Figure 80. Live load testing: truck position 3.

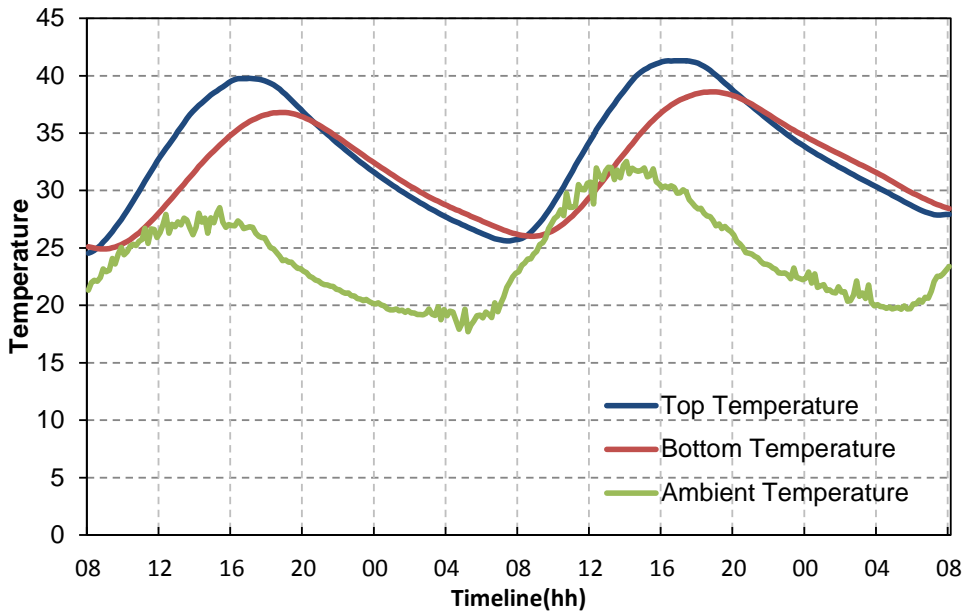
Figure 84. Temperature measurements taken over a 48 hour period during summer: top and bottom of the slab and ambient temperatures.

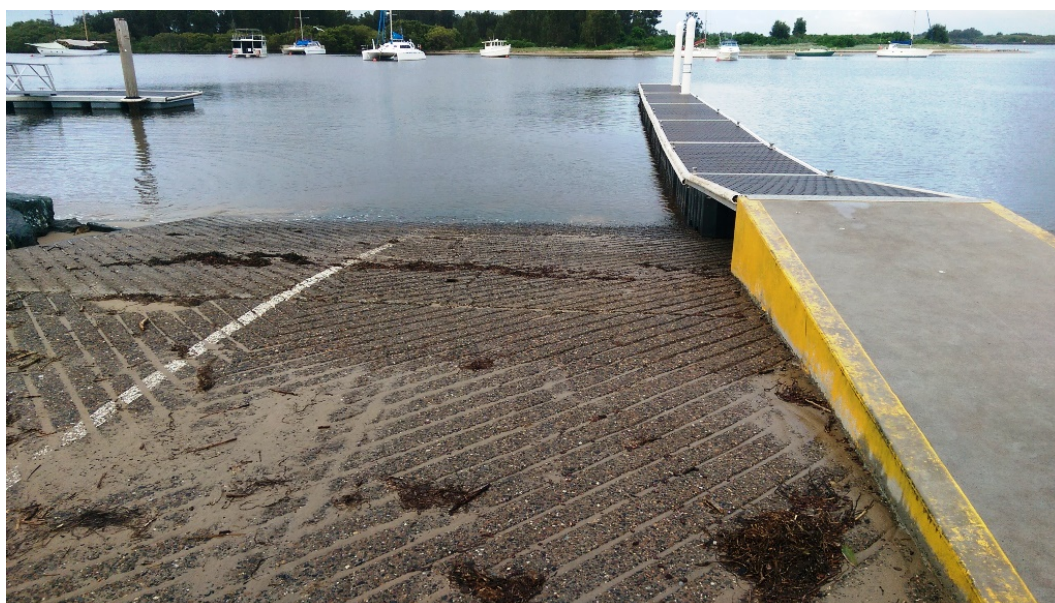
Durability of Geopolymer concrete in marine environment is under investigation at the Westport Boat Ramp Stage 2 Works at Port Macquarie, NSW. As shown in Figure 99, the aged boat ramp built with cast-in-place OPC concrete was replaced by precast Geopolymer concrete planks. Wagners was selected as the contractor by the Port Macquarie Hastings Council for supply of the planks.

Figure 99. Site view of Westport boat ramp project at Port Macquarie, NSW.

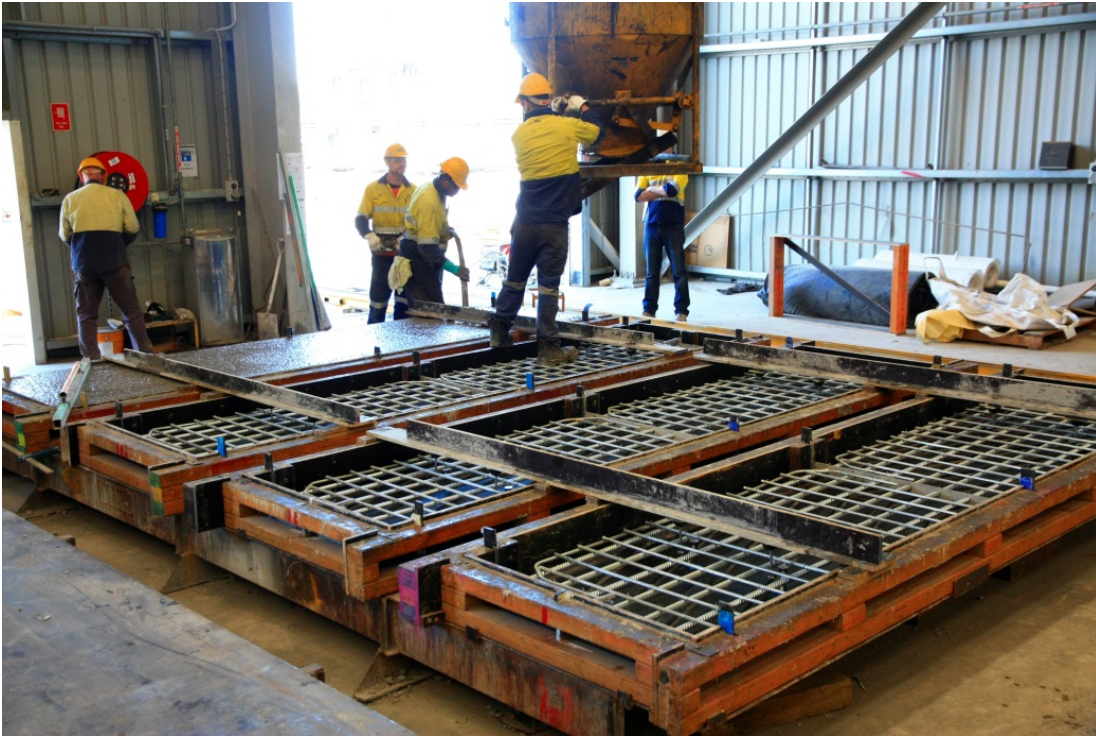
Figure 100 illustrates the design of the precast EFC plank and the layout of reinforcement. Figure 101 shows the process of casting EFC concrete for four planks at one batch within Wagners precast yard A completed plank after 7-day curing is given in Figure 102.

Figure 101. Concrete casting of four boat ramp planks at Wagners precast yard at Wacol, Queensland.

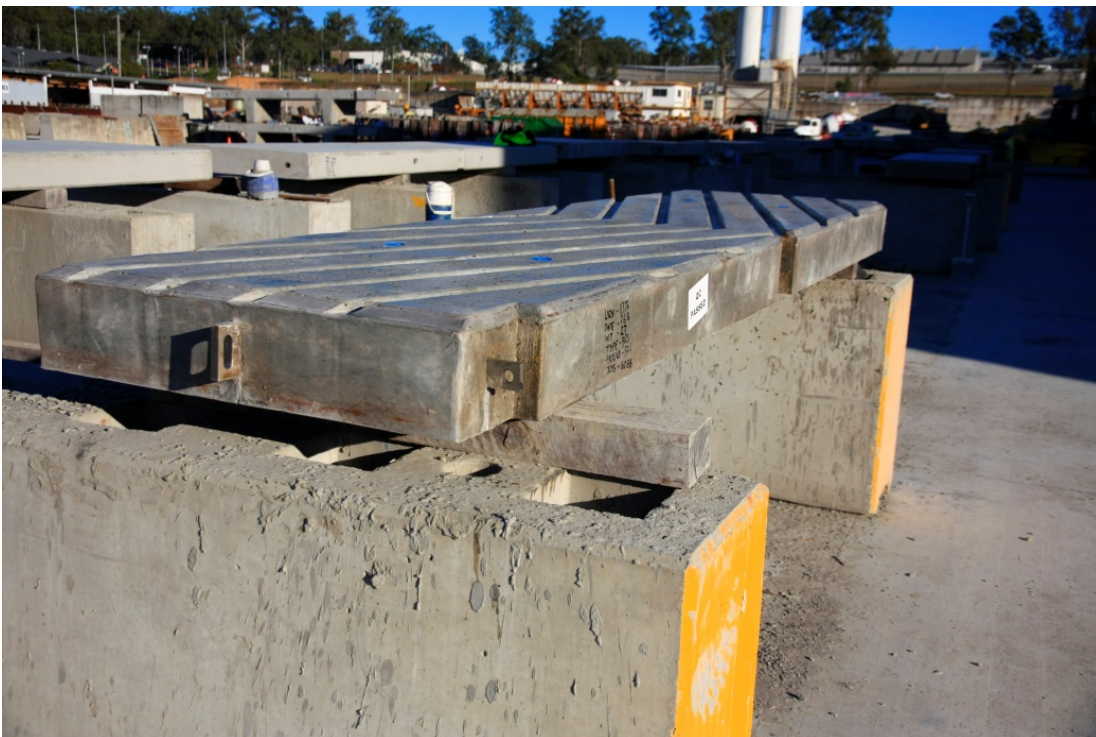
Figure 102. Completed EFC boat ramp plank after curing.

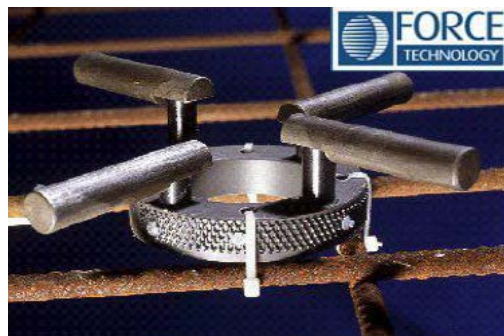
The Corrowatch sensor (Figure 105) measures conditions in concrete structures in terms of temperature, current and potential. It works as an early warning system by monitoring the status of corrosion in concrete. The progress of chloride penetration in the concrete as well as steel corrosion will be extensively investigated over time following the procedures established in ASTM-C 876 “Standard Test Method for Corrosion Potentials of Uncoated Reinforcing Steel in Concrete”.

The Corrowatch sensors were mounted on the reinforcement bar in the EFC plank/panel. The sensors were installed at a minimum spacing of 500 mm between each other. Figure 104 shows the locations of the Corrowatch sensors in the EFC plank at Zone 1.

Figure 105. Corrowatch sensor (PCTE).

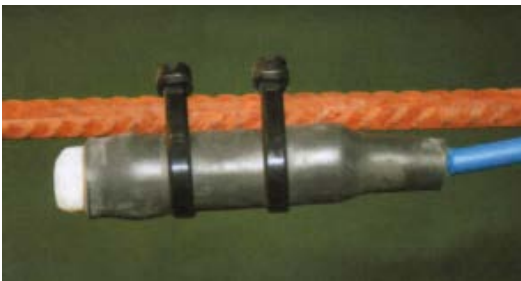
The ERE 20 reference electrodes (Figure 107) are required for corrosion monitoring by Corrowatch sensors. They will be mounted close to the Corrowatch sensors. The potential of ERE 20 is virtually independent of changes in the chemical properties of the concrete. It can be used in wet or dry concrete, whether exposed to chlorides or to carbonation.

Figure 107. ERE20 reference electrode (PCTE).
