LOW CARBON LIVING
CRC

Project RP1020

Field Performance of Geopolymer Concrete
Structures

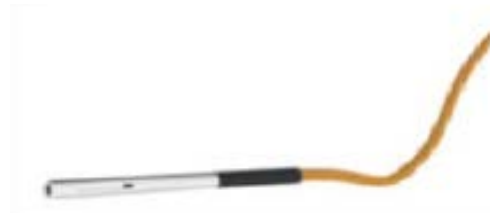
Figure 108. Hygrotemp humidity sensor (PCTE).

Hygrotemp humidity sensor (Figure 108) can measure the relative humidity at certain depth within the concrete.

The humidity information is needed for both monitoring the drying process of EFC and calibrating the pH readings from the pH probe.

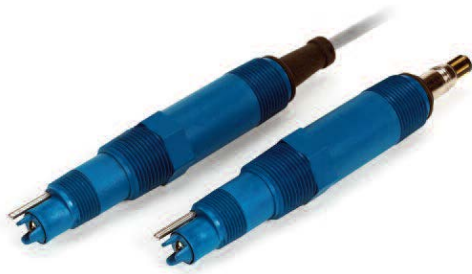
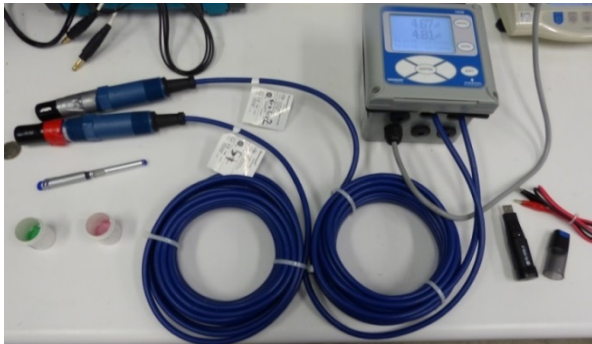
Figure 109. pH probe and data transmitter system.

The pH value of concrete is a vital parameter for interpreting steel reinforcement corrosion in concrete. It has been quite challenging to monitor the in-situ pH value of concrete due to high alkalinity condition. The research team at UNSW has successfully developed a new pH monitoring system of Geopolymer concrete in the laboratory, as given in Figure 109. By embedding the pH probe in EFC plank/panel, this project features the very first field trial on continuous pH measurement of Geopolymer concrete.

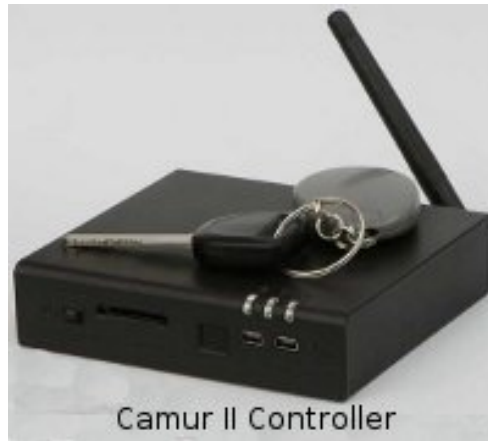
Figure 110. Caumur II controller (PCTE).

The Camur II controller (Figure 110) is a small-form-factor field computer capable of communicating with multiple sensors and on-board data storage. Each sensor functions as a node and is connected with the controller using one single CAN bus cable. The concrete

corrosion data, such as current of corrosion, humidity potential, pH value etc., are collected and stored in the controller at a pre-defined frequency (e.g. once per hour). Coupled with a 3G/4G wireless modem, the controller can be accessed and programmed from a remote office server in wireless.

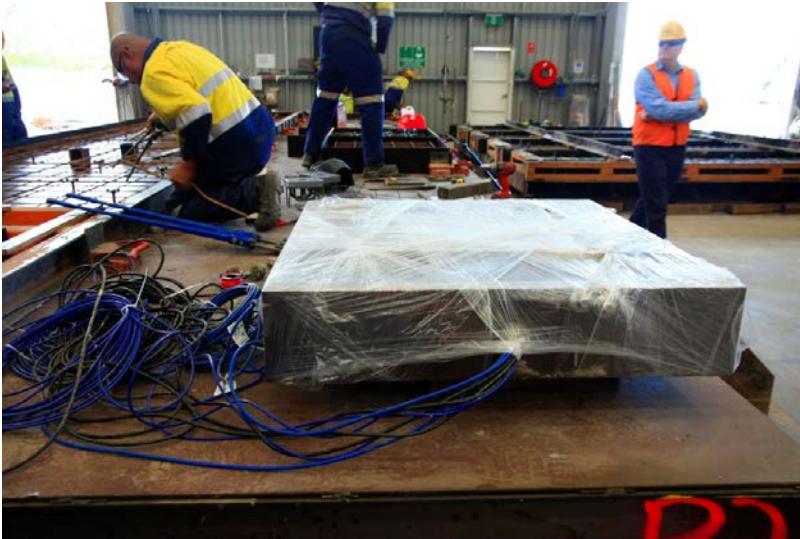
Figure 112. Precast EFC panel with sensors embedded at Wacol, QLD, and ready for transport to site (June 2016).

Figure 111 shows the sensor installation for one EFC panel at Wagners precast yard at Wacol, QLD. The 1 m x 1 m EFC panel (Figure 112) was cast and transported to the site at Port Macquarie in June 2016.

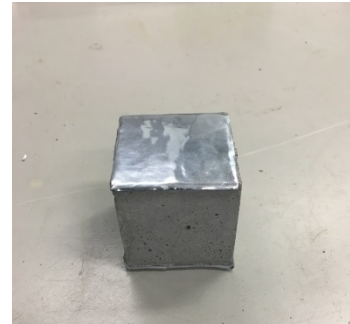
Figure 114. Specimen before sealing for exposure condition.

After specimen preparation, the specimen assembly was proposed through which the specimens were hanged on site. This was the most important step in this experimental study as the assembly must be durable and at the same time easy to handle. First of all the top and bottom surface of the specimens were coated with aluminium foil to avoid multidirectional exposure of specimens. Figure 114 represents the graphical diagram and picture of specimen top and bottom surface sealed for unidirectional exposure.

(b) Specimen with sealed top and bottom.

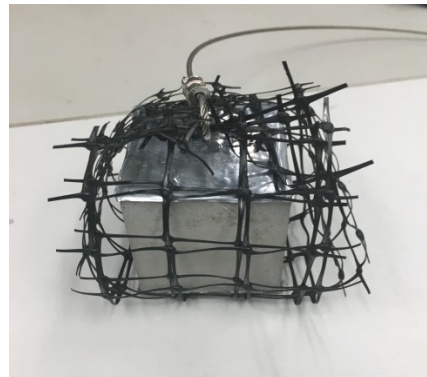
Figure 115. Specimen with the net assembly for hanging.

Next, plastic net having high tensile strength and chemical resistance were cut in such a way, that the specimen completely rest in side and all 6 surfaces are completely covered. For safety purpose, two nets were used for one specimen. Figure 115 represents the net assembly for hanging the specimen with and without the specimen has been placed inside it after sealing their top and bottom with the aluminium foil.

(b) After placing the specimen inside the net for hanging.

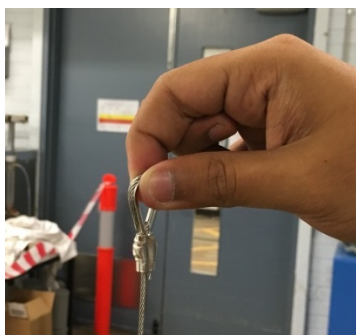
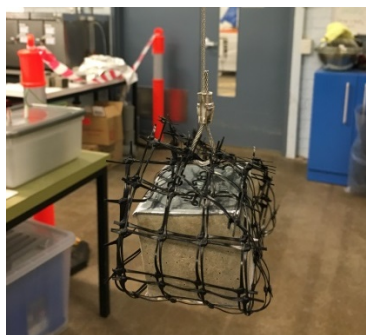
Finally, a hanging assembly was made using a 2 mm durable stainless steel wire with swages to connect them with the top side of net. So to keep wire move freely in a vertical position it is tightened on top of net making a loop and swage it. Considering the site conditions, 1 m long wire was cut for each specimen; after connecting the wire at both ends, the total length remaining was 900 mm. Figure 116 shows the swages on top and bottom of the wire and the total assembly before hanging.

(a) Top Swage.

(b) Bottom Swage with specimen.

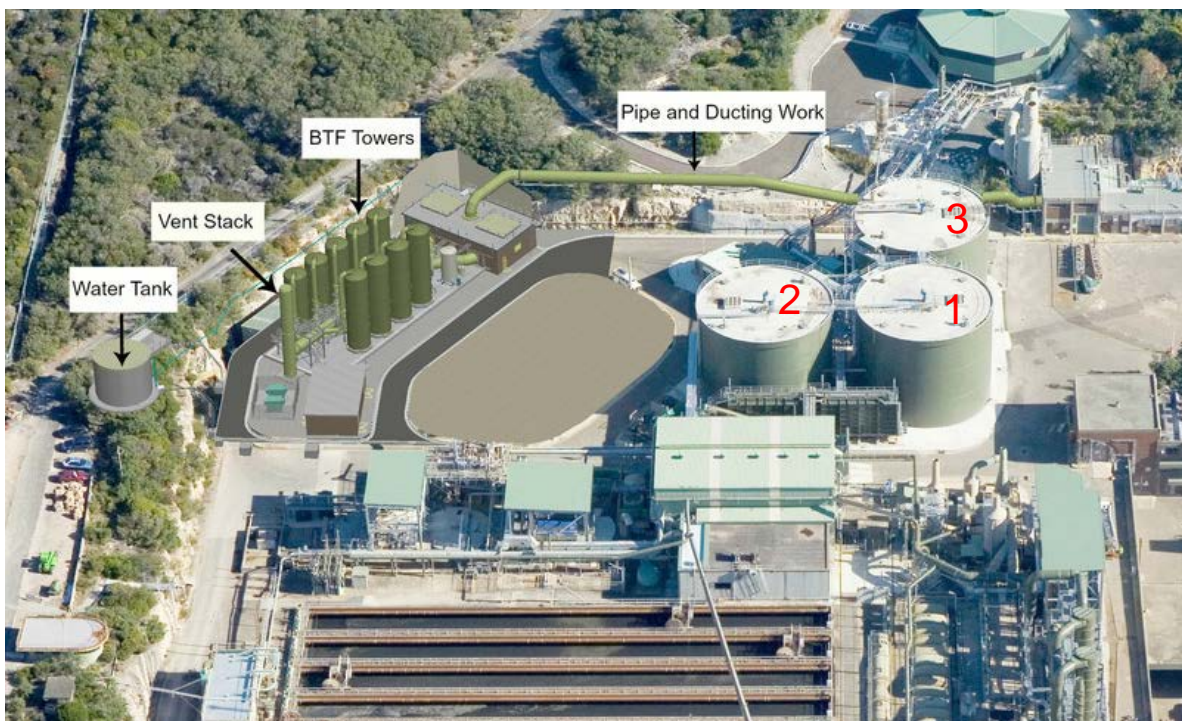
Figure 117. Aerial view of North Head Wastewater Treatment Plant showing digester numbers.

Figure 117 shows an aerial view of the site locations of North head waste water treatment plant (WWTT) run by Sydney Water. The plant is the second largest WWTT in Sydney and runs 24 hours a day, 7 days a week.

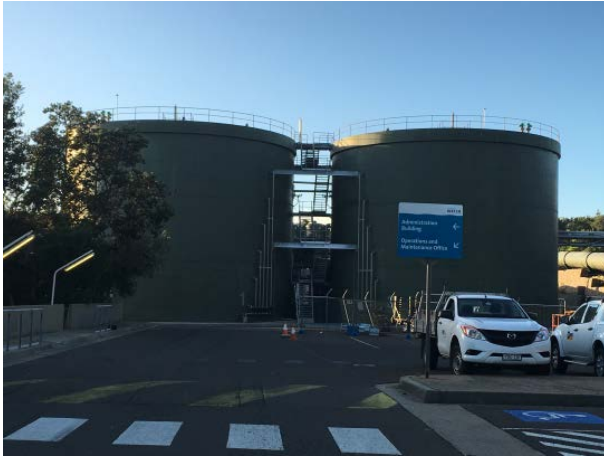
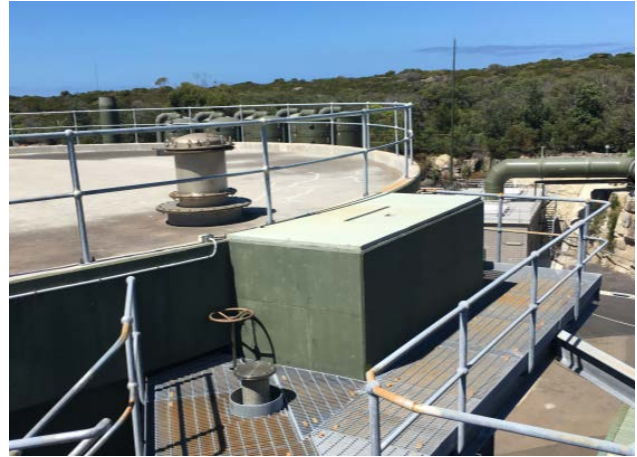
Figure 118. Digesters at site for hanging the specimens.

There were actually 3 digesters on site as shown in the aerial view. Figure 118 shows the digesters and the small drain where the specimens were placed on site. The specimens were hanged in all three digester drains for the comparative study. The atmospheric concentration of hydrogen sulphide (H_2S) and temperature was also noted for past 2 weeks just to understand the severity of the environment present inside these digesters. Odalog gas logger was used for this purpose and data was saved at a regular interval of 3 min for 13 days. Figure 119 shows the gas monitoring system placed in the sewage drain of digester.

(a) Digesters 1 (left) and 3 (right).

(b) Drain at digester 2 where specimens were placed.

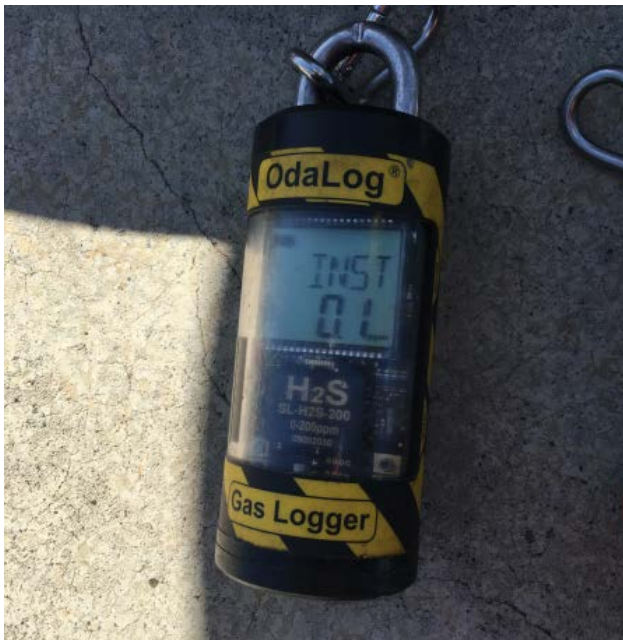
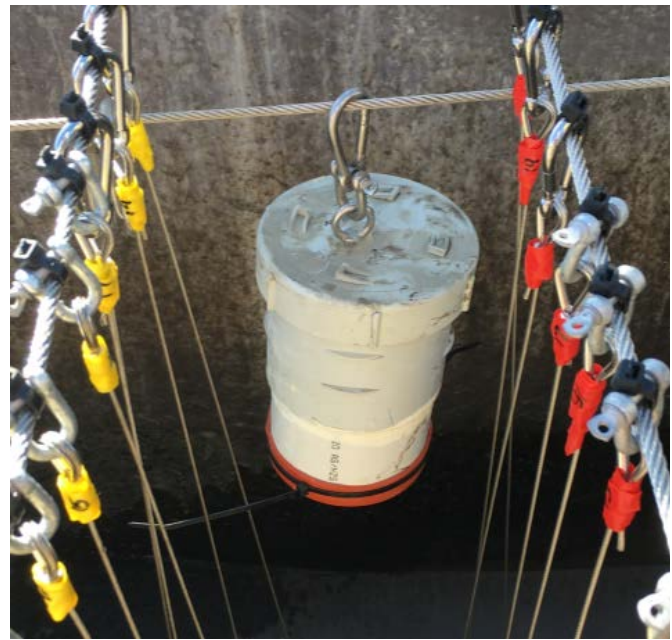
Figure 119. OdaLog data logger placed inside the drain for measuring the H₂S concentration and temperature.

(a) OdaLog Data logger for H₂S and temperature.

(b) Placed inside drain hanging from wire.

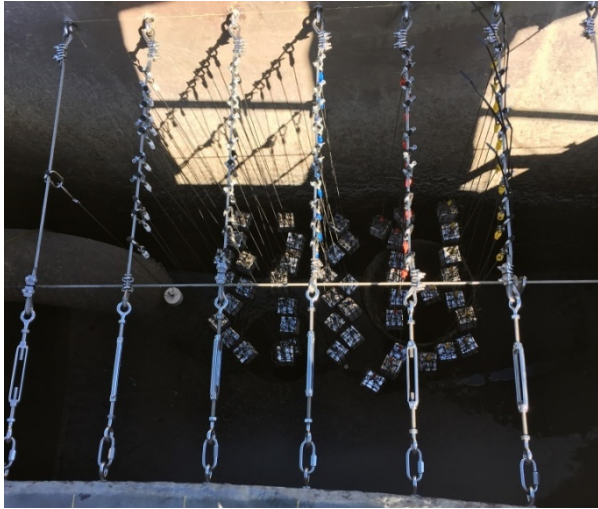
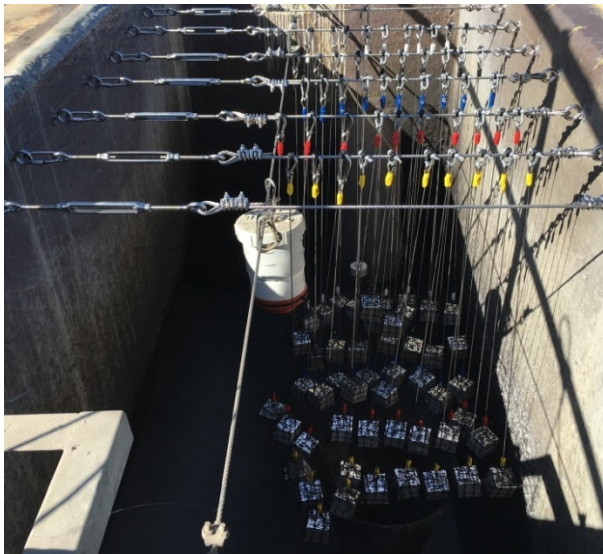
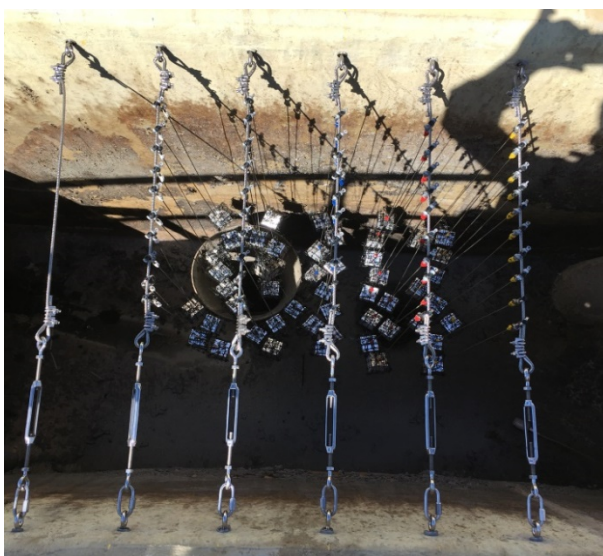
Figure 121. Specimens hanging pattern in each digester.

supports only 10 specimens of each type. The digester 1 contains serial # 1 to 10 for each type of mortar specimens, whereas digester 2 contains serial # 11 to 20 and digester 3 contains serial # 21 to 30. Figure 121 shows the hanging pattern of different specimens in digesters 1, 2 and 3.

(a) Specimens Hanging in digester 1.

(b) Specimens hanging in digester 2.

(c) Specimens hanging in digester 3.

The coupon samples being tested have been suspended in these tanks where rapid deterioration of the OPC concrete had previously been observed. They are not laboratory conditions.

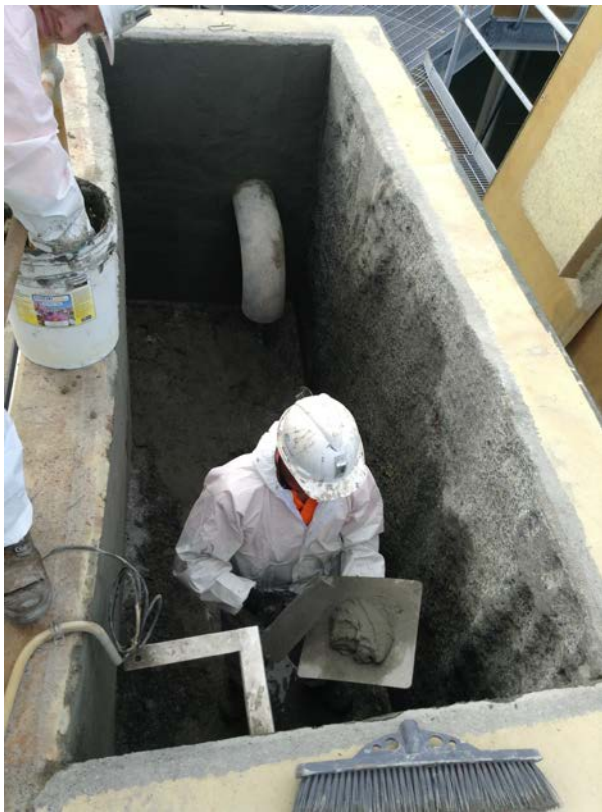
Recent inspections of the tanks (taking the coupon samples for periodic testing) showed the Milliken lining was still in good condition with no visible deterioration having been in service for more than 2 years. The performance of the lining compared to the deteriorated OPC concrete substrate is encouraging.

Figure 122. Application of Miliken's mortar (Geospray) to repair the deteriorated surface drain.

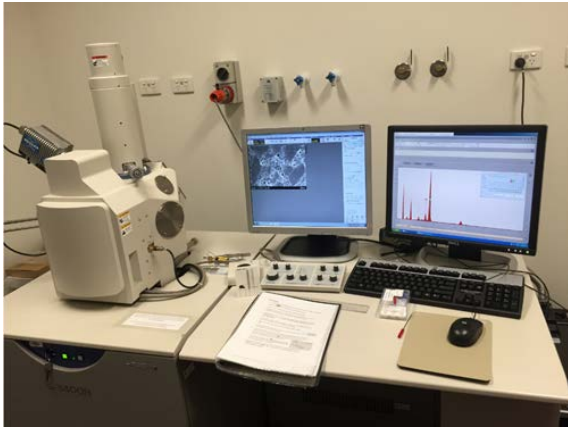
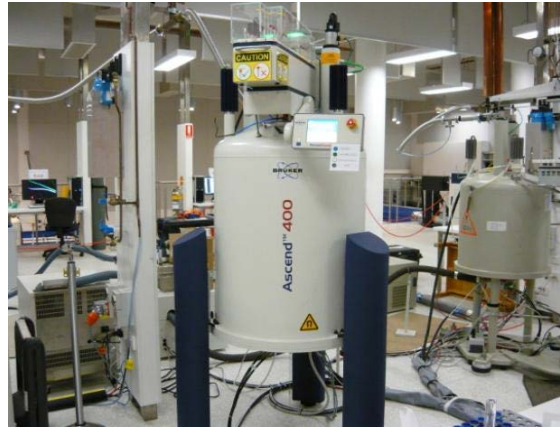
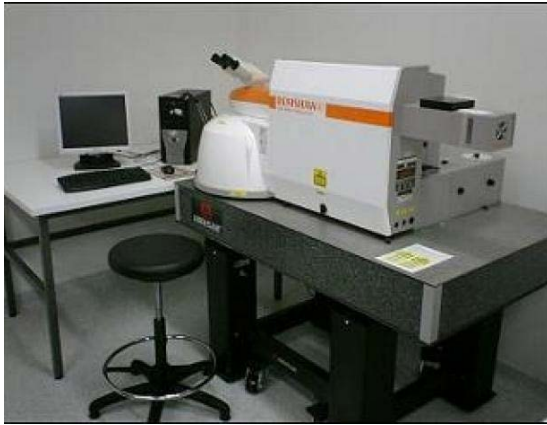
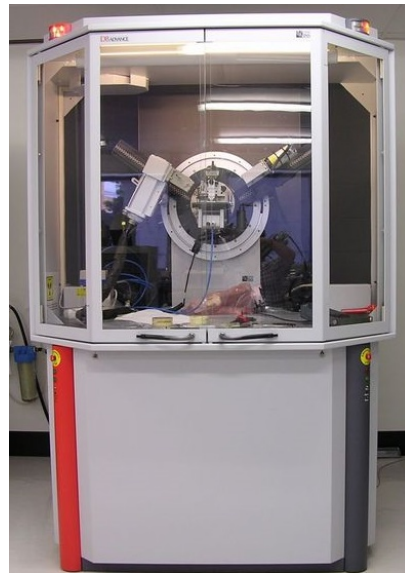
Figure 123. Instruments for microstructural assessment of concrete mortars.

After timely removal of specimens from the site, initially some visual investigations were performed to observe the degradation of specimen in terms of mass loss and neutralization of depth. Further, penetration of sulphuric acid will be observed using phenolphthalein test. Second phase of testing will include microstructural assessment of mortar specimens using scanning electron microscopy (SEM), energy-dispersive X-Ray spectroscopy (EDX), X-Ray diffraction (XRD), Raman spectroscopy, Fourier transform infrared spectroscopy (FTIR) and nuclear magnetic resonance spectroscopy (NMR) techniques at different penetration depths (Figure 123). These are

helpful in assessing the mechanisms underlying the effect of severe environmental conditions on different Geopolymer and cement mortars. Figure 123 represents all the instruments available at the analytical centre, The University of New South Wales which is used for microstructural studies.

(a) SEM/EDX.

(b) NMR spectroscopy.

(c) Raman spectroscopy.

(e) XRD spectroscopy.

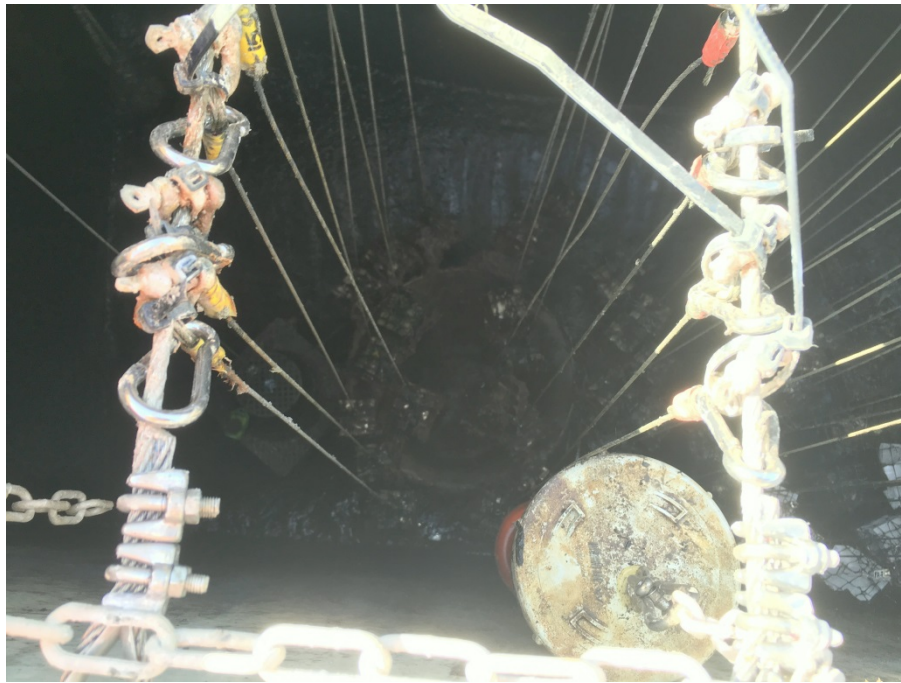
Figure 124. Specimens at the time of removal from digesters.
